Gelcoat Quality Guide

A guide to application faults and possible causes

Common faults in gelcoat - Scott Bader has the answers

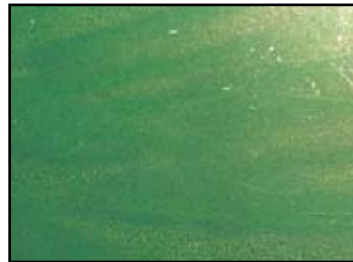
COLOUR TEARING

- Pigment separated from resin
- Improper spray technique
- Long geltime, sagging

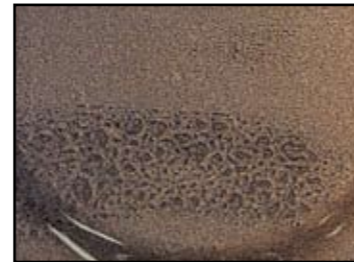
COLOUR MOTTLING

- Gelcoat loow in thixotropy
- Poor pigment compatibility
- Viscosity too low

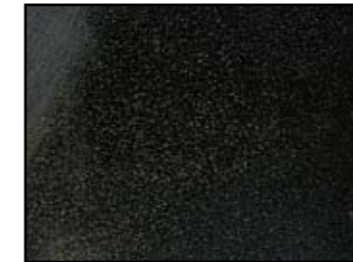
POROSITY

- Gelcoat too viscous to release air
- Cold gelcoat and/or mould
- Gelled too quickly, entrapping air

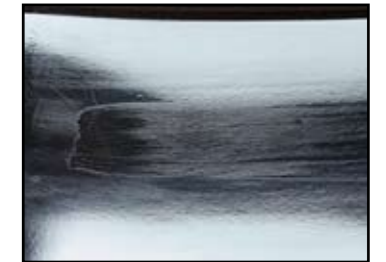
'WATER MARKING' ETCHING ON MOULD

- Areas of thin, double gelcoating on mould
- Two colours gelcoated on mould
- Solvent attack

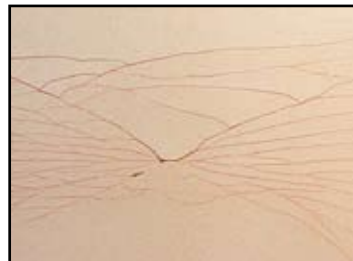
PARALLEL CRACKS

- Flex cracking
- Gelcoat too thick
- Laminate too thin/flexible

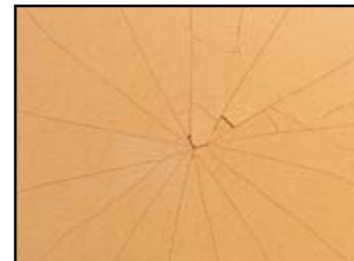
STAR CRACKING

- Reverse impact
- Gelcoat too thick
- Crack pattern transferred from mould

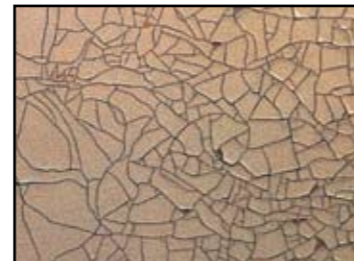
CRAZING

- Chemical attack
- Excessive heat
- Contamination

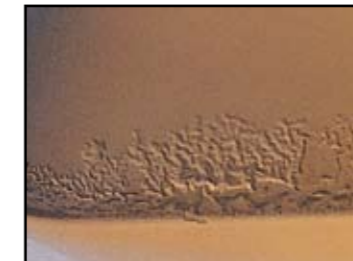
WRINKLING

- Insufficient cure
- Gelcoat too thin
- Back-up too rapid

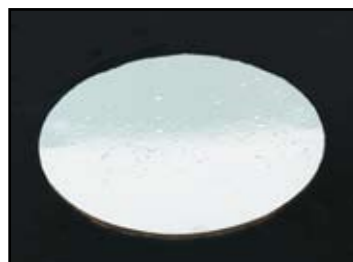
BLISTERS IN LAMINATES

- Water ingress
- Damp reinforcement
- Air voids

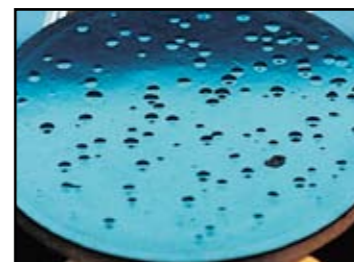
GELCOAT BLISTERS

- Air voids on release
- Unreacted catalyst
- Solvent contamination

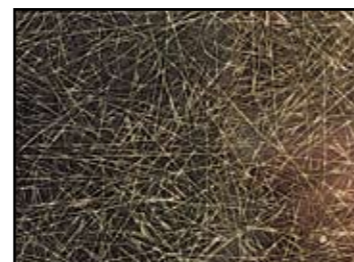
FIBRE PATTERN

- Gelcoat too thin
- High exotherm in laminate
- Insufficient cure, released too soon

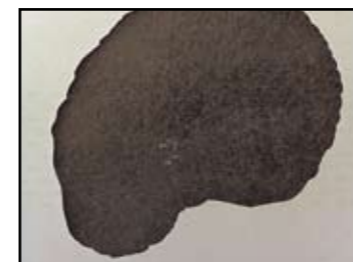
GELCOAT PEELING

- Contamination
- Gelcoat too fully cured
- Geltime too long - release wax dissolved

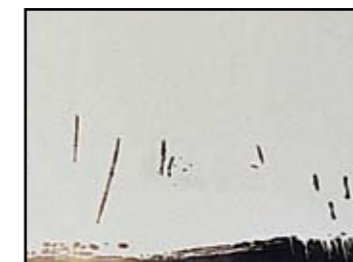
DE-WETTING (BRUSH)

- Brush gelcoat applied too thinly
- Incompatible release system
- Contamination

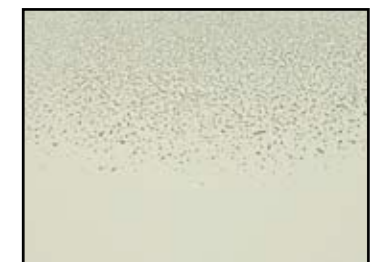
DE-WETTING (SPRAY)

- Spray gelcoat applied too thinly
- Incompatible release system
- Contamination
